## Rain can damage rotor blades

Test stand facilitates the simulation and analysis of the influence of weather, climate and production faults

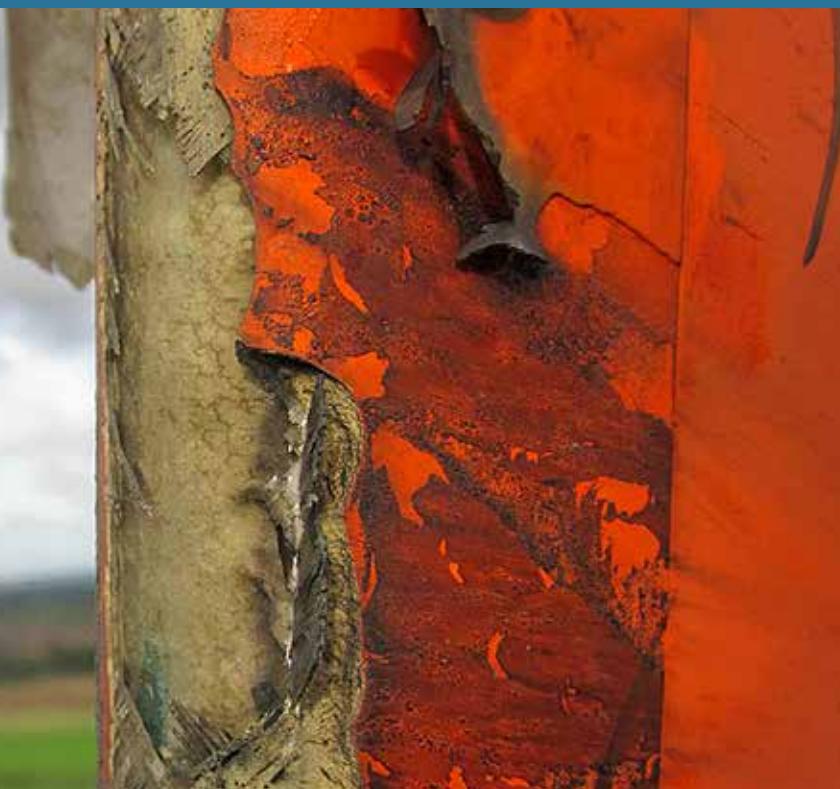
*Rain and other weather and environmental factors can have a detrimental effect on the rotor blades of wind turbines in the long term. The leading edges of the blades are particularly susceptible to damage. Here the protective layer erodes first and material degradation subsequently continues deeper into the blade structure. A new test stand is now investigating the mechanisms involved in rain erosion in detail. The aim is to provide better protection for rotor blades in the future so that they can be used longer, thus improving the economic viability of wind turbines.*

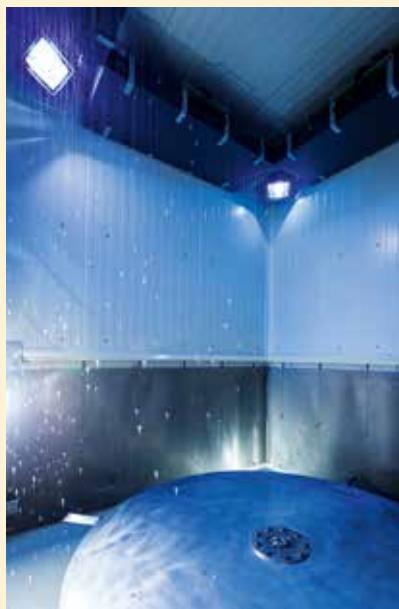
**Fig. 3** View inside the test stand: on the left the rotating disk with a sample holder that 1–2 mm sized raindrops impact upon. Top right: image with different drop sizes. Left: 1–2 mm; Right: 4–5 mm.

The test stand can vary the quantity of rain between 6 and 24 l/min and the drop size between 1 and 5 mm (Fig. 3). The samples pass through a rain area of 2 m<sup>2</sup>. A preliminary investigation observed the drop forms and quantities in practice and analysed and compared them with those generated in the test stand.
